608199 Corr. D480180MS

PCB for Isolator XP Sensor Cow

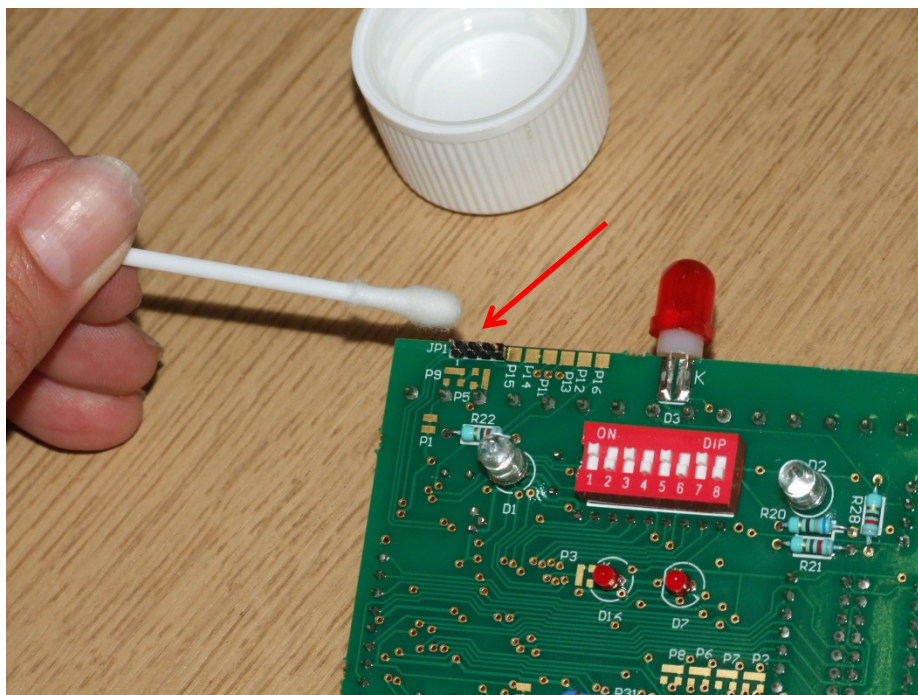
A number of PCB's were found to function normally but unable to connect to a PC for programming by GMTTools. They are able to enter 'monitor mode' using the front button but were not visible to the software. On inspection it was found that small amounts of lacquer, used in the normal production process, had over spilled onto the connection pins.

All stock PCB's that were unable to connect were cleaned using the following process and were then reliably addressed for programming. Further PCB production will have this issue eliminated.

1. Soak ear bud with IPA
2. Clean four connection pins thoroughly top and bottom
3. Blow excess IPA off board
4. Allow IPA residue to evaporate before testing
5. If connection unsuccessful then repeat with more vigorous pin cleaning
